# Final Report- Research Study on the Sinking Sequence of *MV Estonia*

SSPA Consortium

SSPA Research Report No. 134, 2008

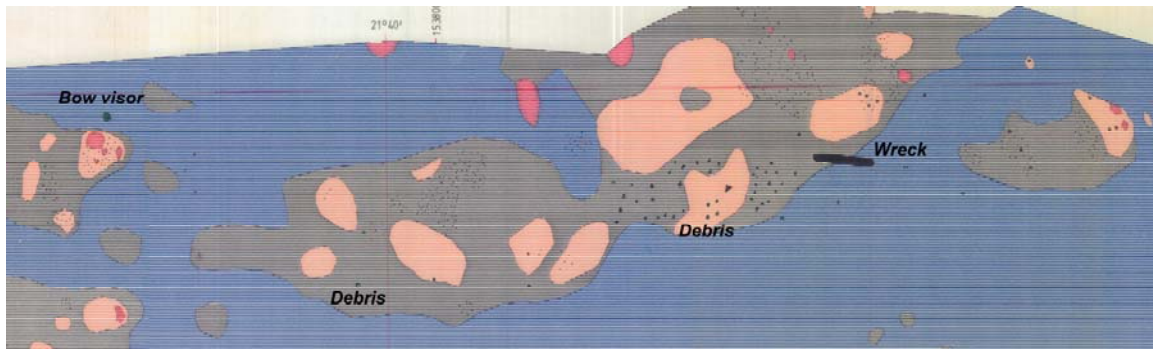
**Fig. 23.** Sonar plot of seabed. Courtesy of Dr. Nuorteva, Supplement No. 501 of [2].  
“Debris” indicates possible lost material from MV Estonia.

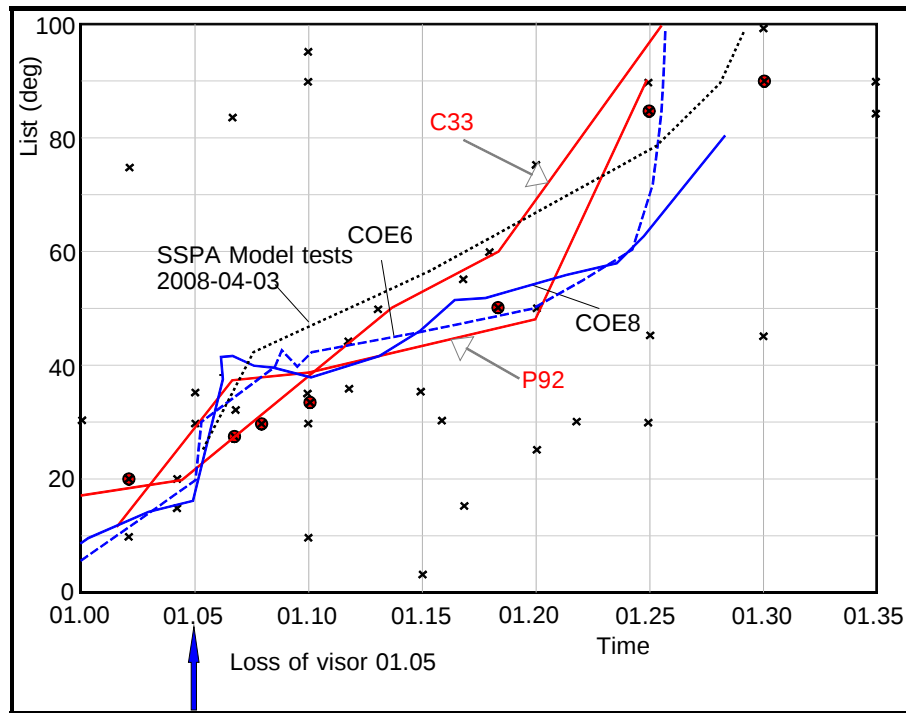
The results from the two simulations 6 and 8 (COE6 and COE8 in Project Report No. 11) have been plotted in the diagram of Fig. 27, where the list angle development versus time is shown. In this diagram is also plotted a number of witness statements (cf. Fig. 3) as well as results from model tests of Project Report No. 12. In simulation 8 the initial heading angle was 240 deg instead of 281 deg.

**Fig. 27.** List development versus time from witness statements C33 and P92 (cf. Fig. 3), SEAMAN simulations (COE6 and COE8), and model test.

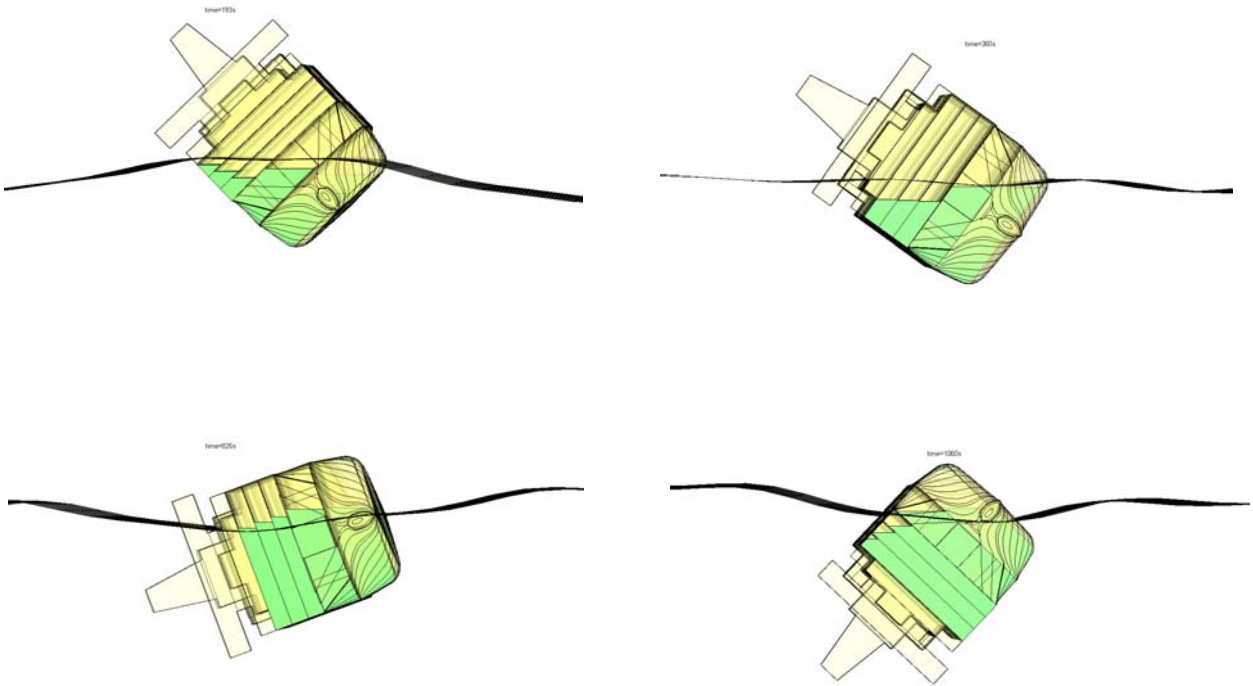
The simulations of the final stage starts with the assumption that the car deck is flooded with 2500 tonnes of water and the ship is drifting at beam seas. In Project Report No. 10 a time series representation of a final stage simulation is shown, where the ship capsizes and finally sinks after 21 minutes.

**Fig. 31.** Snap shots from a final stage simulation with flooded water in green color.

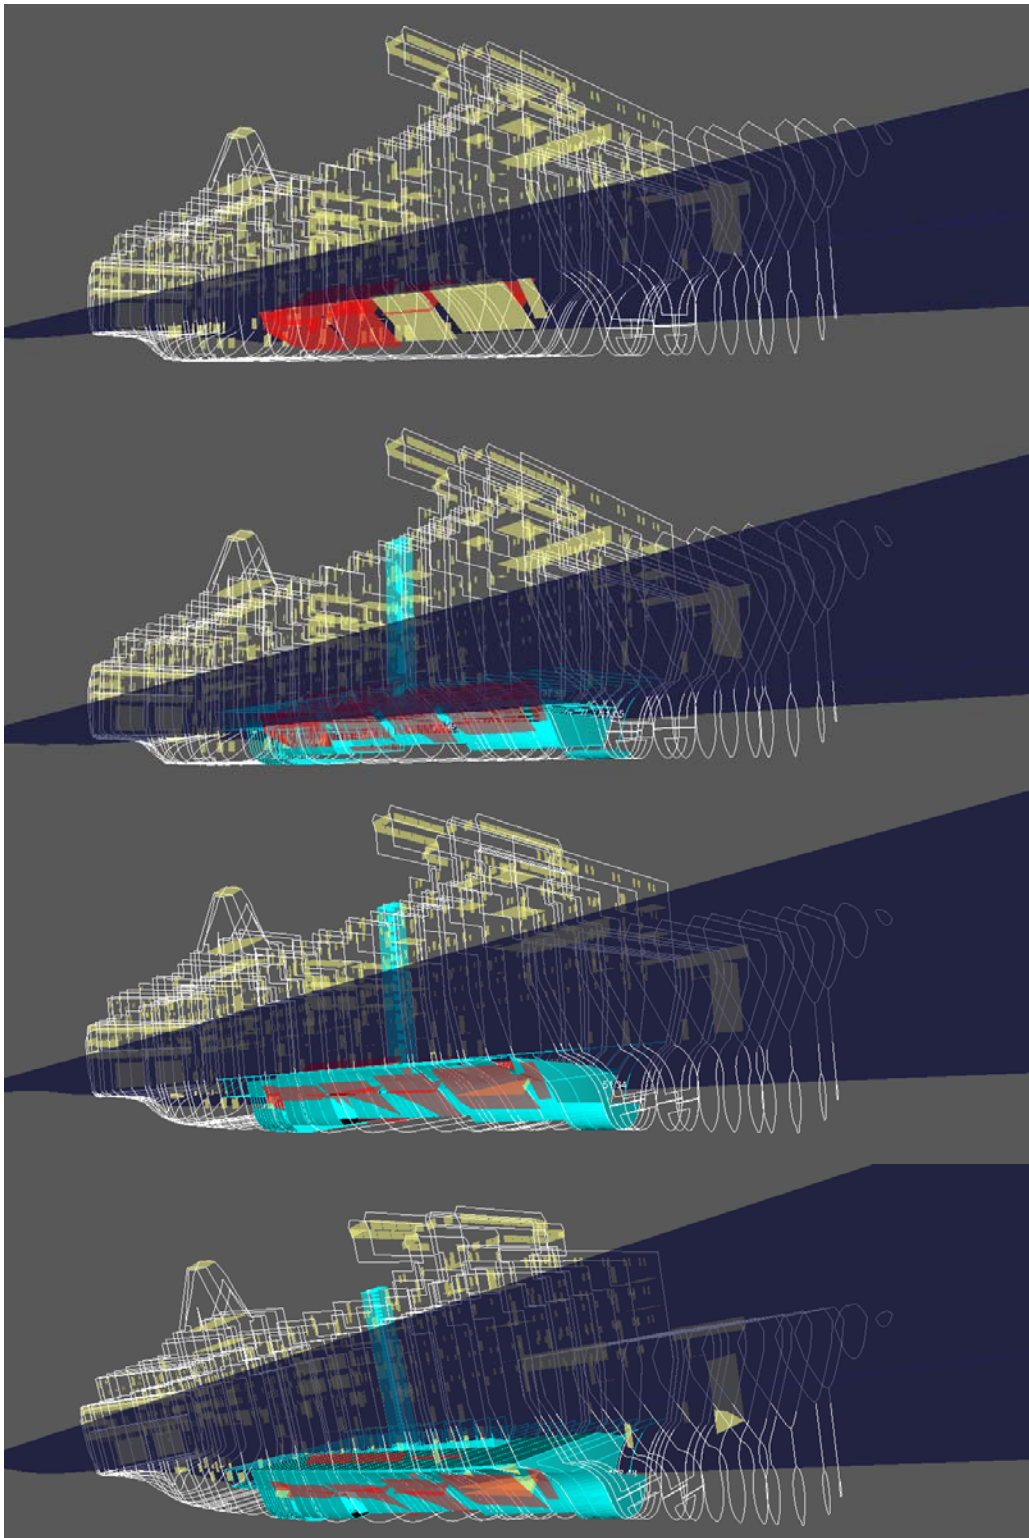
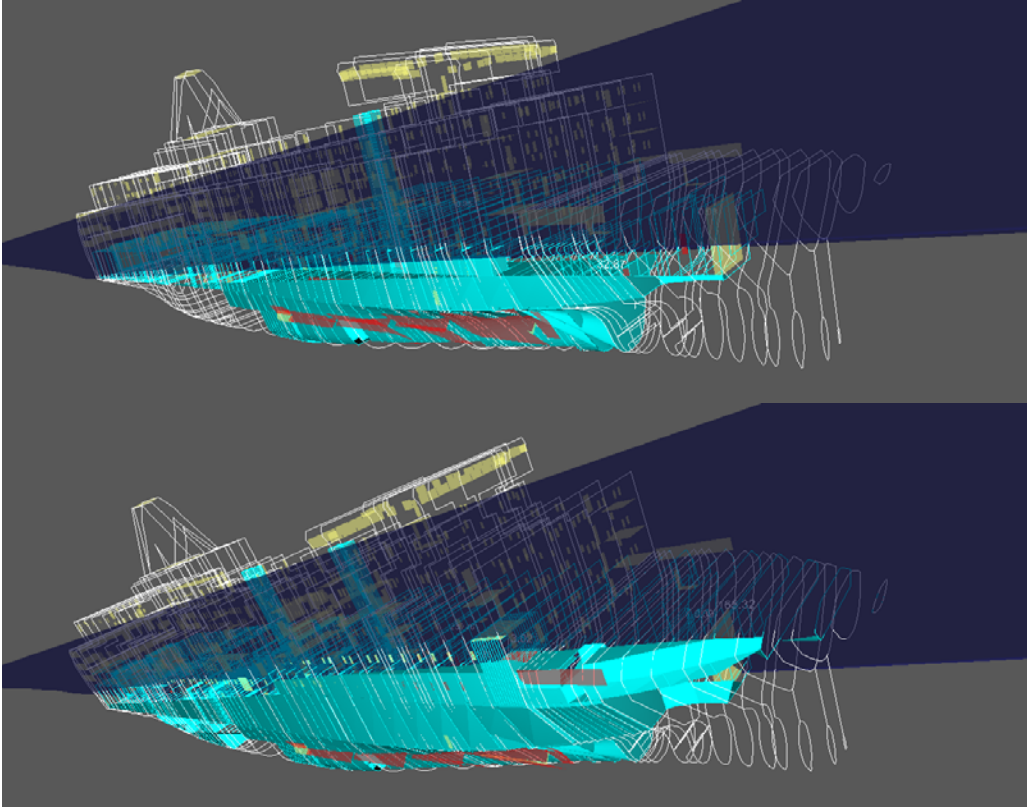
**Fig. 32.** Six snapshots of the PROTEUS3 simulation of flooding of spaces on Deck 0/1 forward, subsequent up-flooding of car deck and development of large angle of heel. Up-flooding can only take place in case of substantial or nearly complete flooding of the lower spaces subject to direct flooding from the sea.

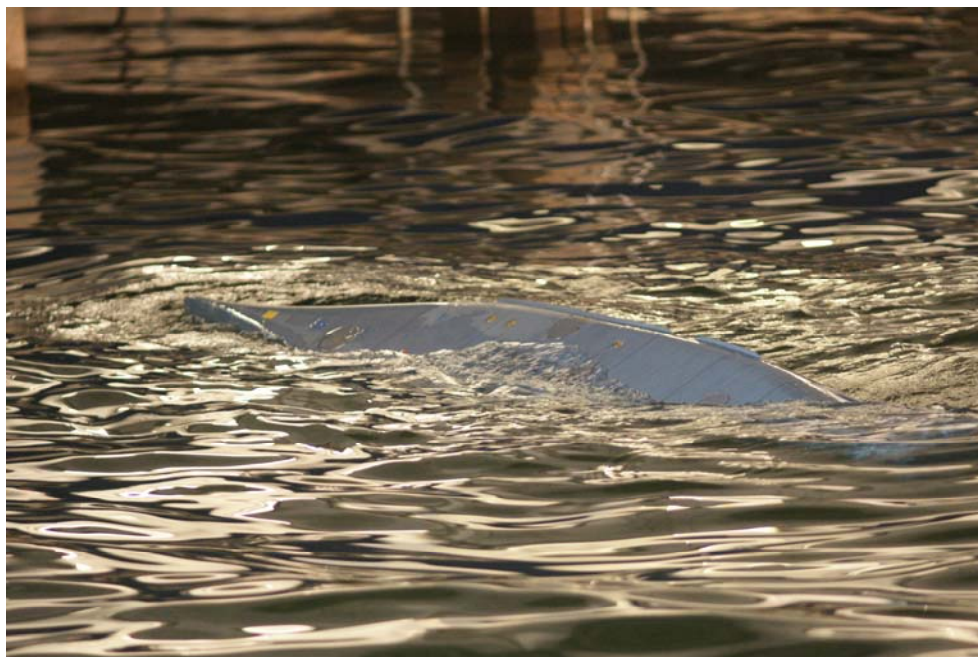
**Fig. 34.** Ship model in heel angle 150-160 degrees. Due to scale effects in air compressibility air was ejected from a calibrated valve at the stern of the model.

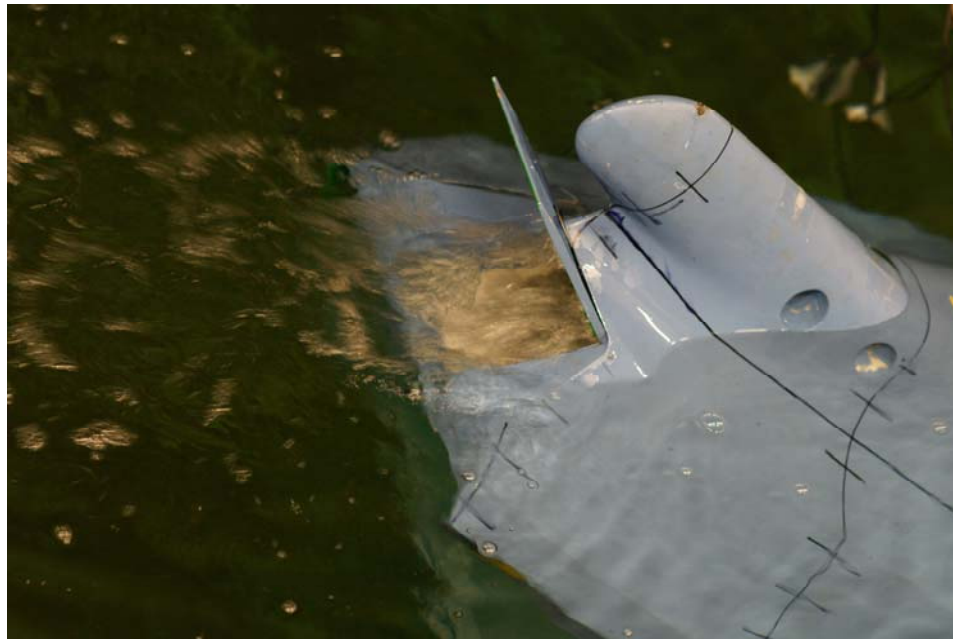
Figs. 34 to 36 show the final phase of the foundering. The ship model sank with stern first and rested with the aft part of the superstructure on the bottom of the basin. The forward part of the ship model with the bulb was now still above the surface. In this position the forward valve was opened a few seconds and now also the bow sank. This means that the amount of air ejected from the model was in the order of 8 litres.

**Fig. 35.** Final phase of the foundering. The stern has rested at the bottom of the basin and air is escaping from the car deck. Due to practical reasons the ramp was forced open during the tests, but would have been closed by gravity by now.

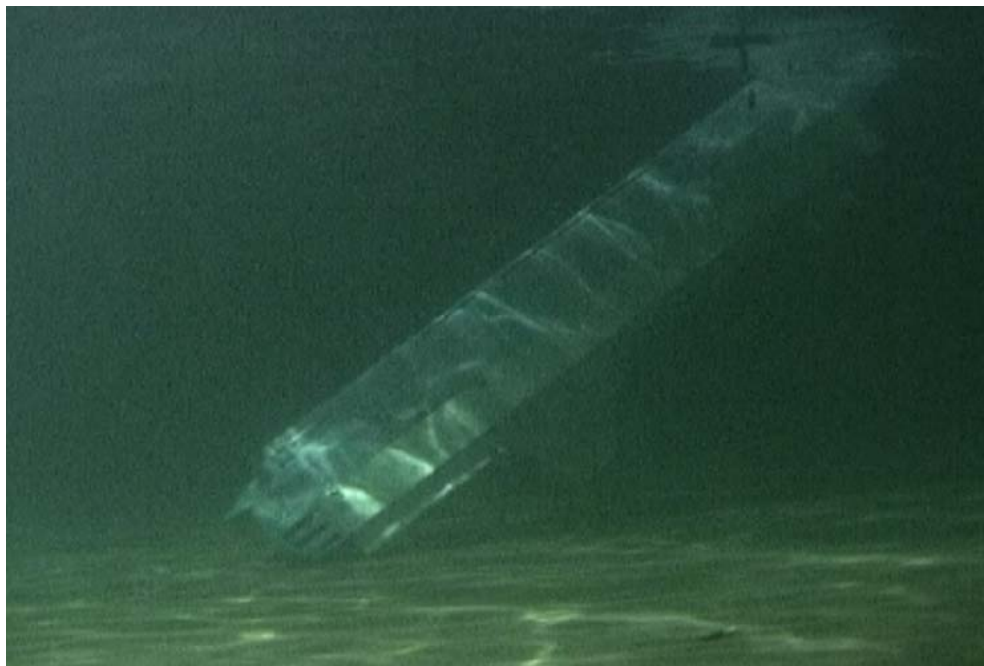
**Fig. 36.** Final phase of the foundering. The aft part is hitting the bottom.

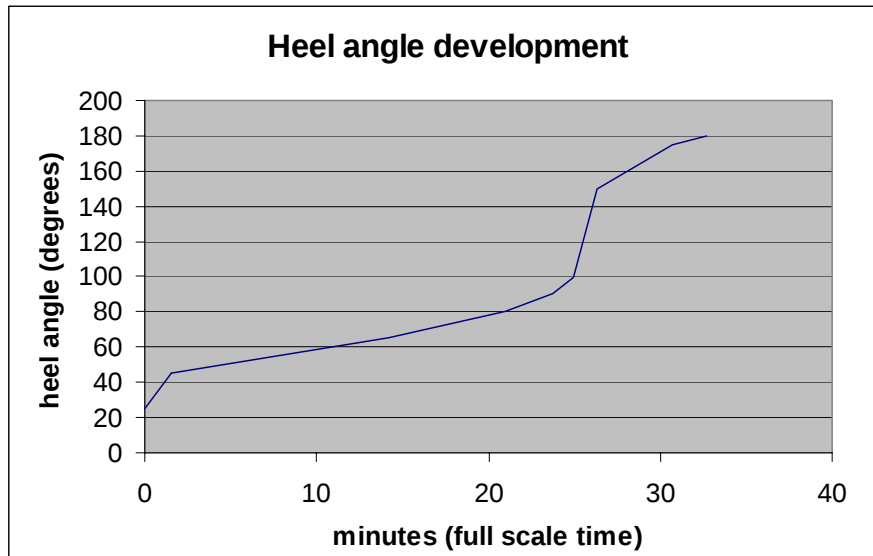
**Fig. 37.** The heel angle development. As soon as the model reached a heel angle of about 40 degrees water started to fill the aft rooms on tank deck through the ventilation shafts. At the same time water flooded Deck No 4. This explains the relatively slow increase in heel angle until the model reach 90-100 degrees. From this point the heel increases rapidly up to about 150 degrees.
