Developments to Further Enhance Safety of Passenger Ro-Ro Ships

Per Stefenson and Willem van Berlekom

SSPA Research Report No. 135, 2008

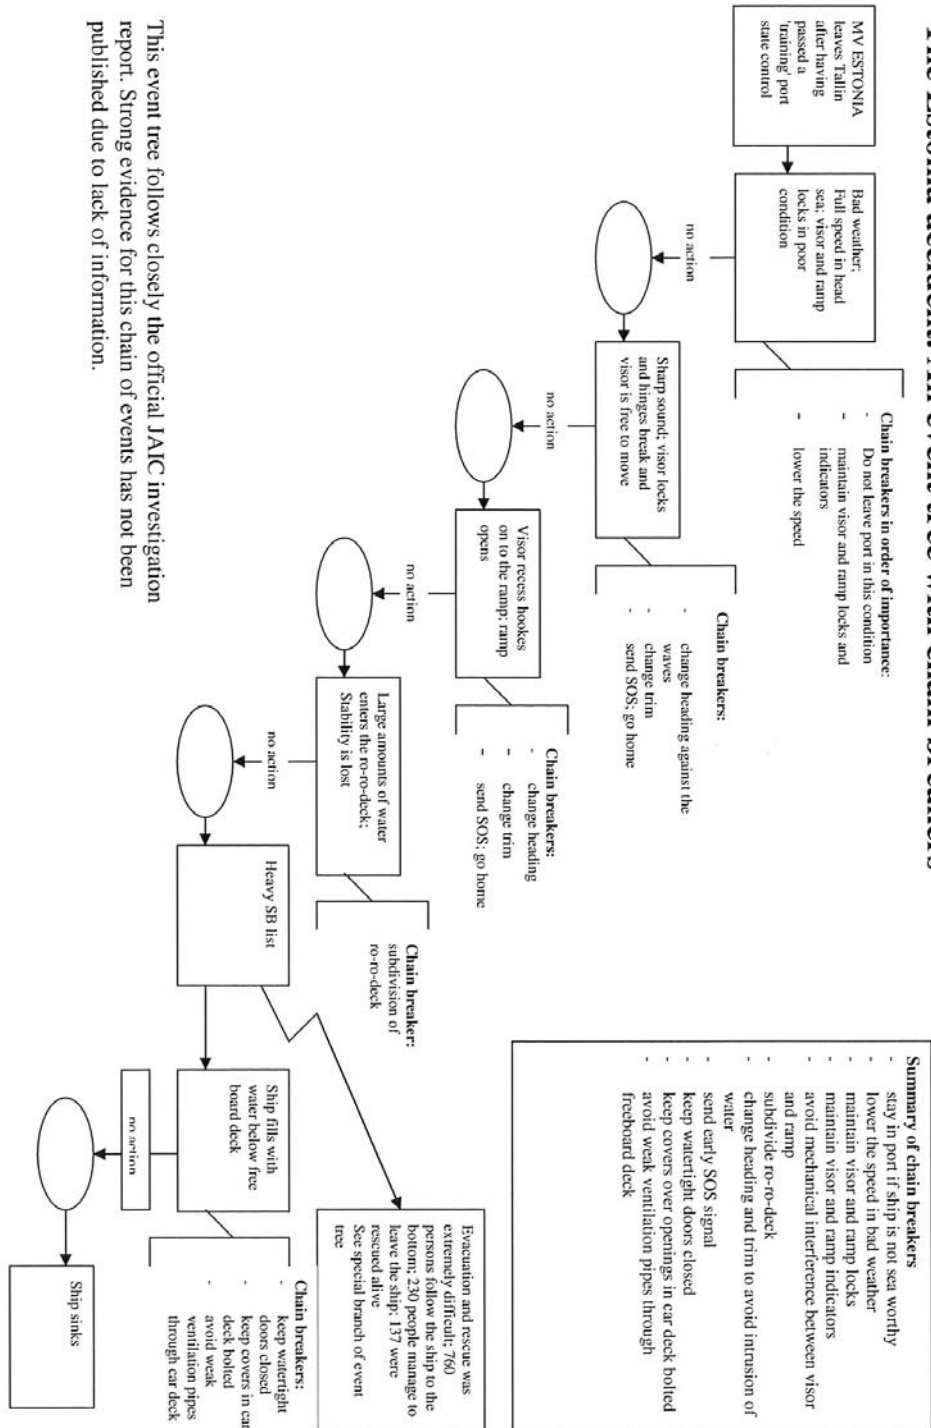
The Estonia accident. An event tree with chain breakers

This event tree follows closely the official JAIC investigation report. Strong evidence for this chain of events has not been published due to lack of information.
