# DESSO – Design for survival onboard

Björn Allenström (editor)  
SSPA Sweden  
Göteborg

SSPA Research Report No. 132, 2006

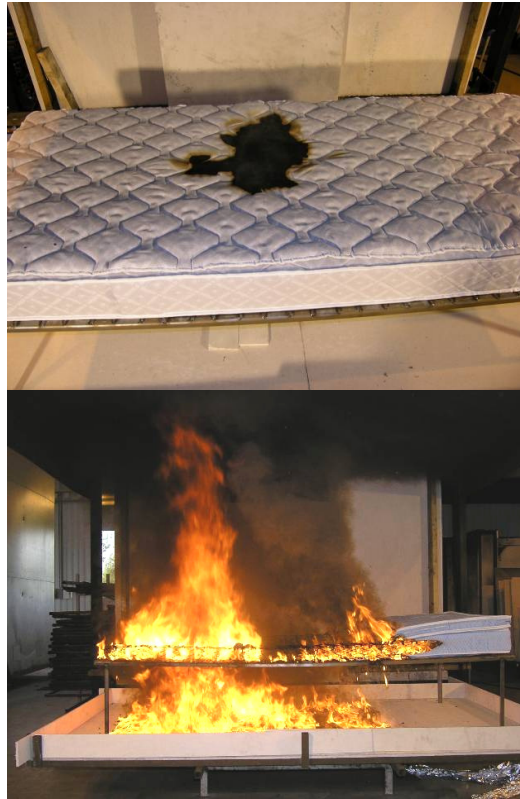
**Figure 5.1** The difference between the fire performance for two mattress types is illustrated in the above photographs. The mattress on the upper picture has high resistance to ignition and exhibits other good fire performance properties, while the mattress on the lower picture clearly has much worse fire performance properties.

fire ignition source. Figure 5.1 illustrates the test performance of two different mattress types.

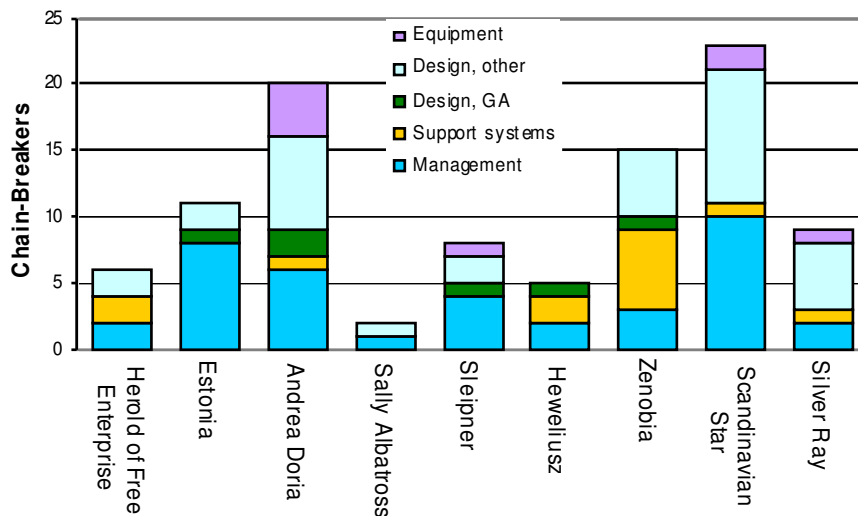
Diagram 5.  
Categorized chain-breakers for each event.

The chain-breakers in the category ‘Management’ are highly represented in all events. For the category ‘Design, other’ the chain-breakers are also highly represented in eight of the nine events. ‘Support systems’ are represented in six events, but, in general, to a lesser degree and ‘Design, GA’ and ‘Equipment’ in five and four events, respectively, to a rather small degree.

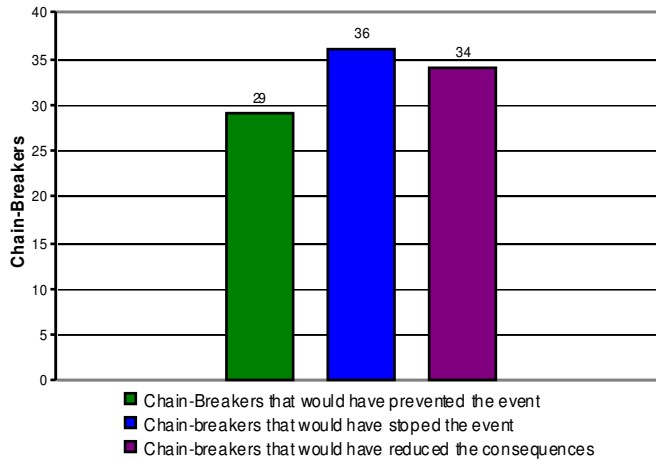
*Diagram 6. Categorization of the chain-breakers depending on what they would have achieved.*

The number of chain-breakers in each category is fairly similar, Diagram 6. If we split the categories into what kind of chain-breaker it is, Diagram 7, the distribution will differ depending on their type.

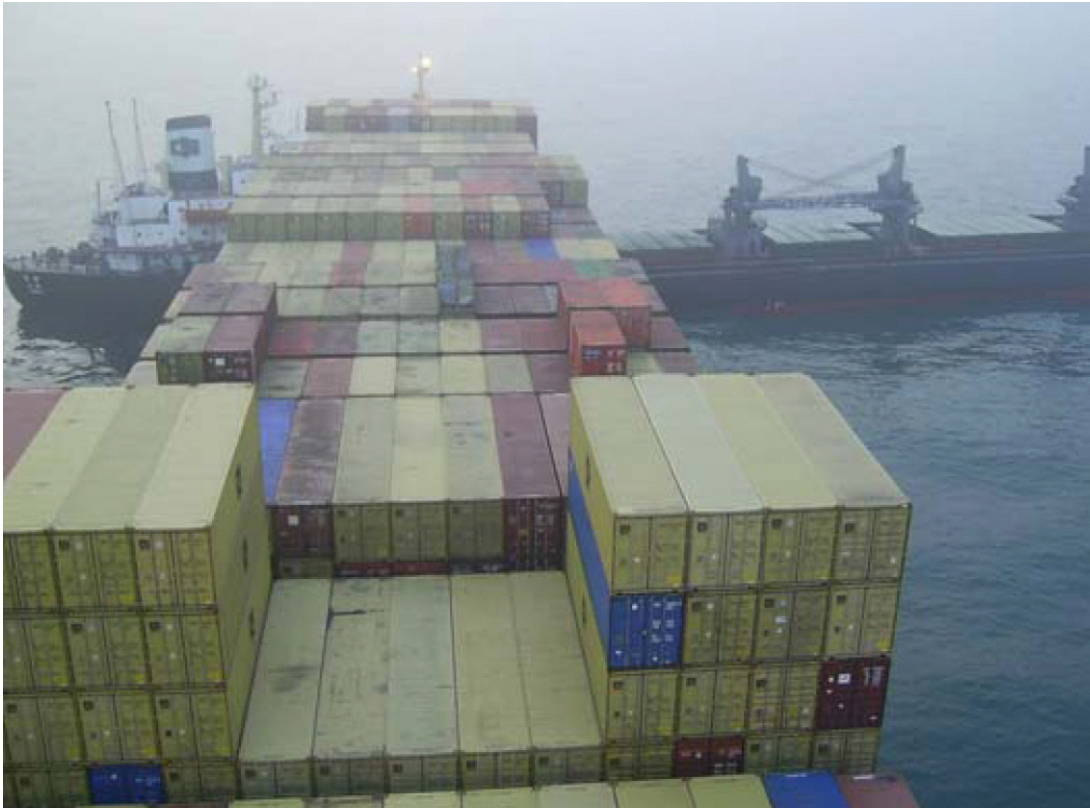
**Figure 1 A Panamax container ship in collision with a handymax/general cargo ship.**

The penetration is almost 100% e.i. the bulk ship is almost cut in two.  
The horizontal extension is moderate. The vertical extension is "unlimited. The medium and large size container ships (panamax and post-panamax) with high speed and great mass possess an enormous inertia.

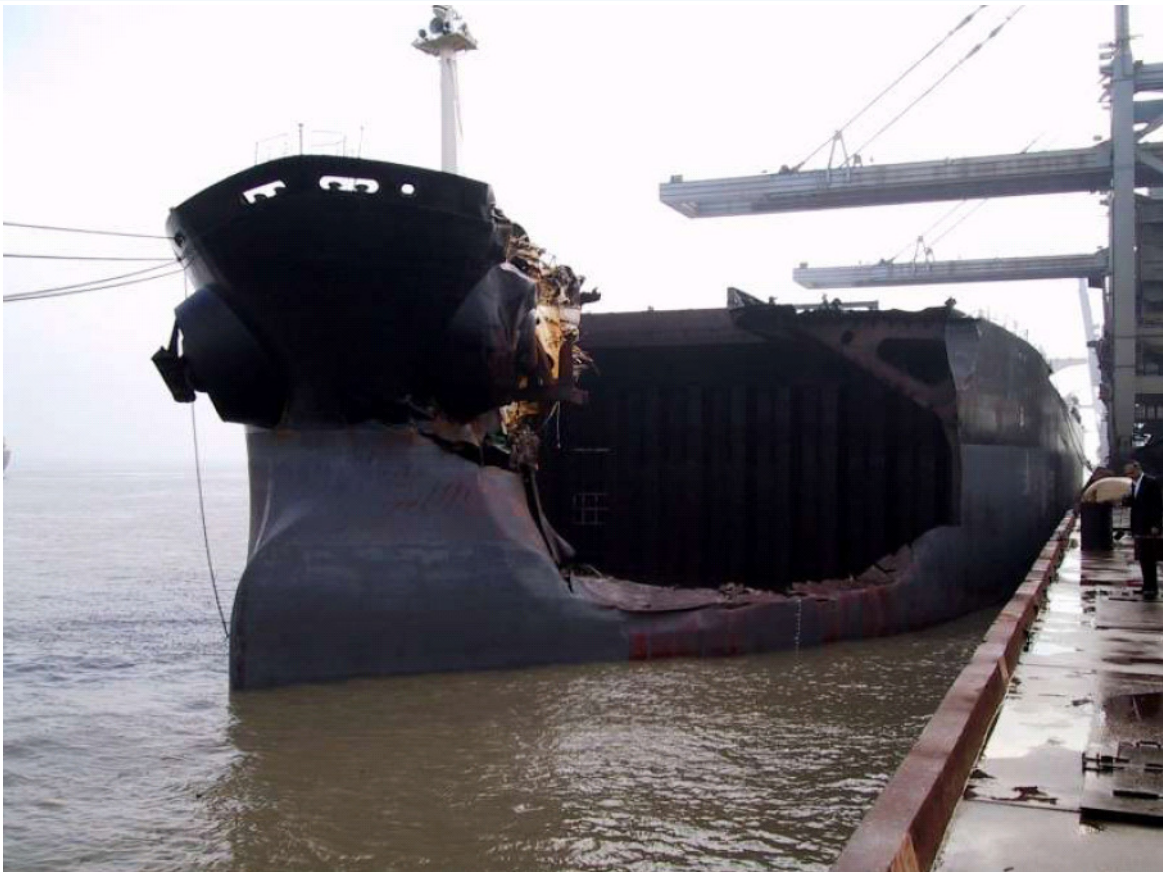
**Figure 2 A VLCC in ballast after a collision with a fully loaded cape size bulkship. The collision angle was about 45 degrees**

The penetration is up to B/2 (see also picture 1).

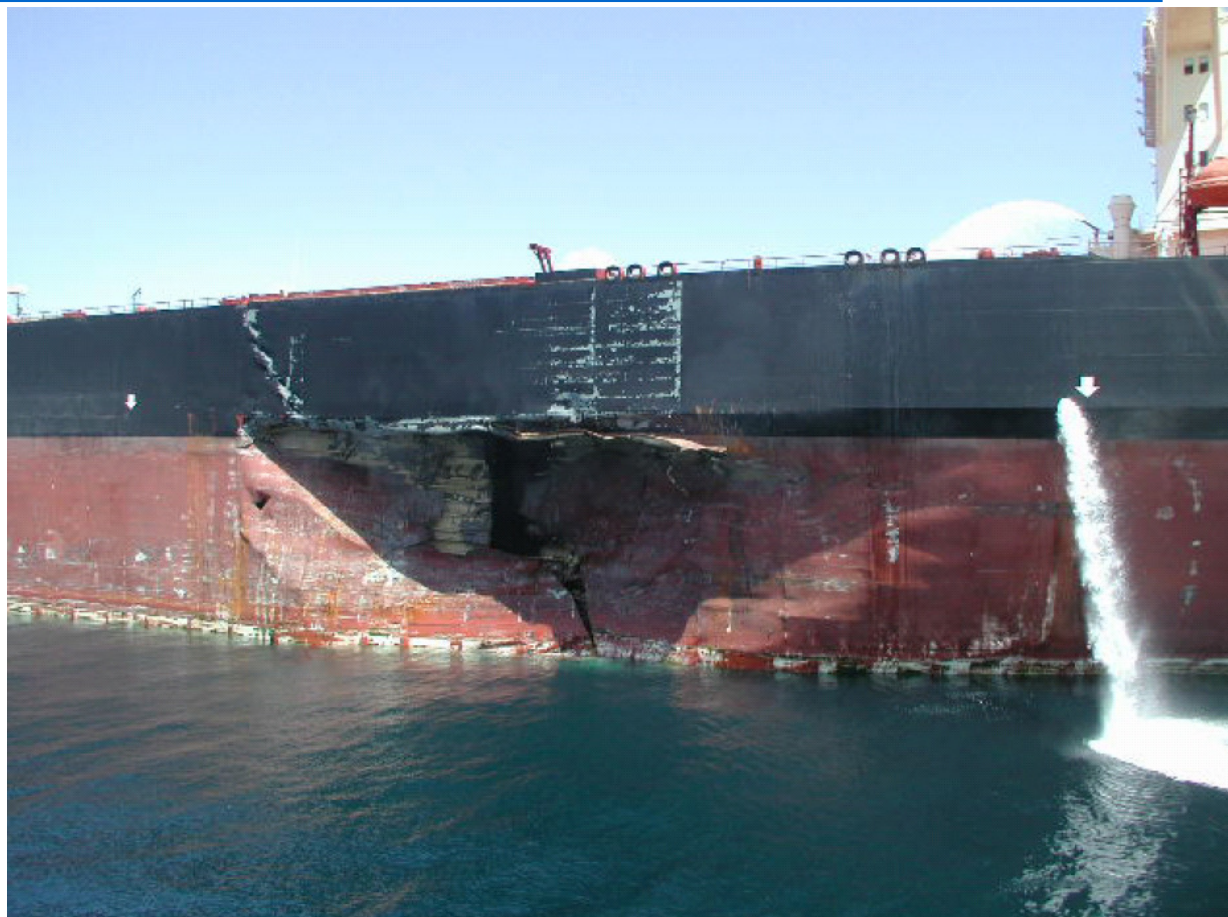
**Figure 3 A VLCC after a collision with an OBO in ballast. The collision angle was about 90 degrees. The penetration is about to B/5.**

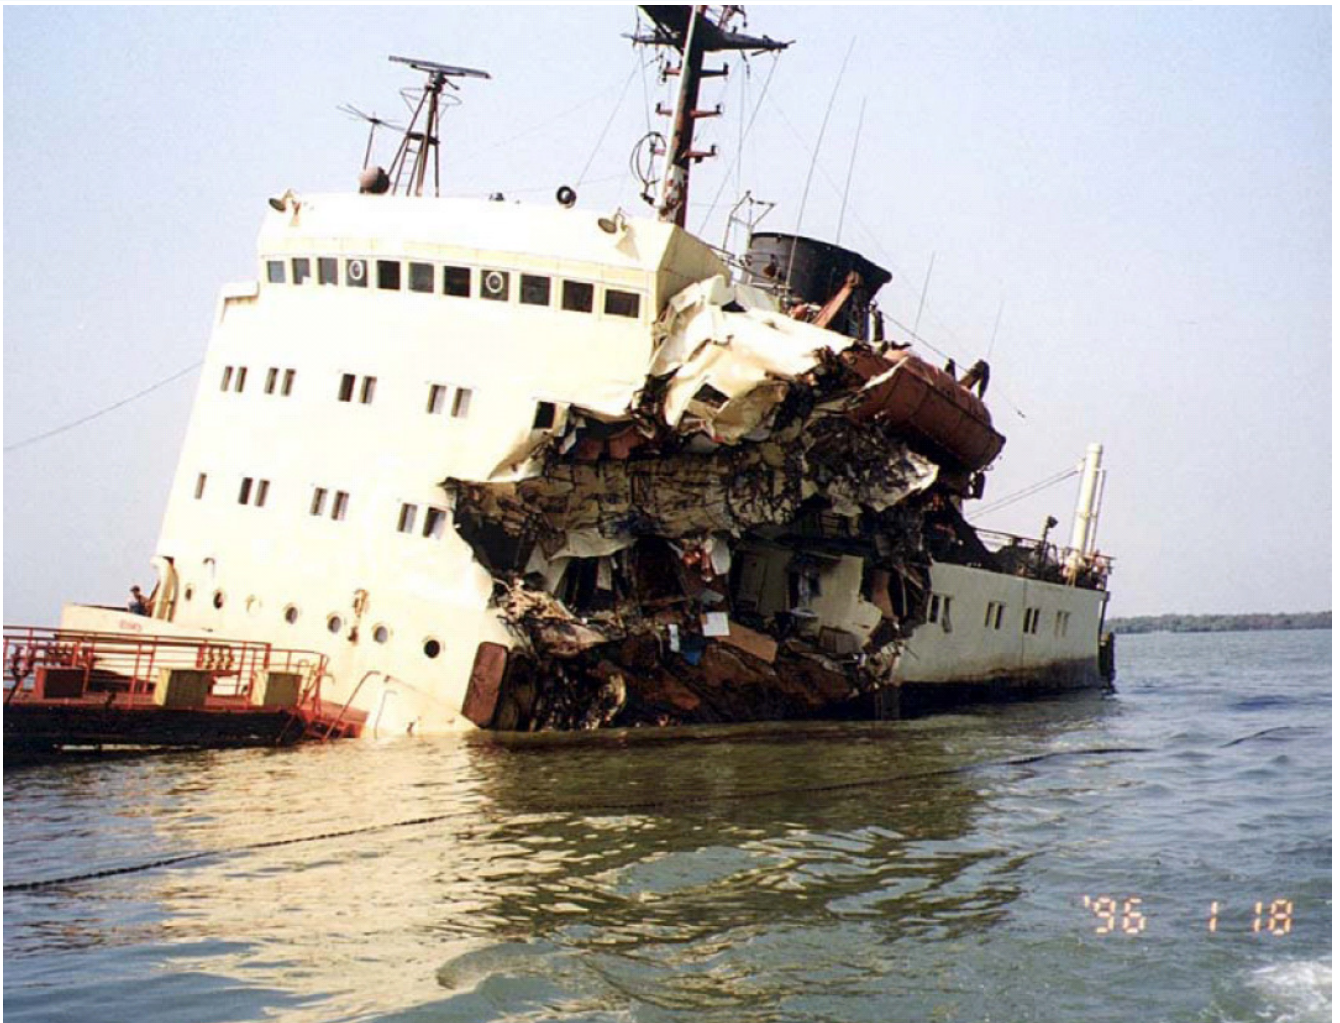
**Figure 4 A product tanker after a collision with a container feeder ship.**

The collision angle was about 25 degrees. The collision started at about L/2 and ended in the superstructure aft. The bulb of the feeder ripped open on one side all the tanks from L/2 to aft.

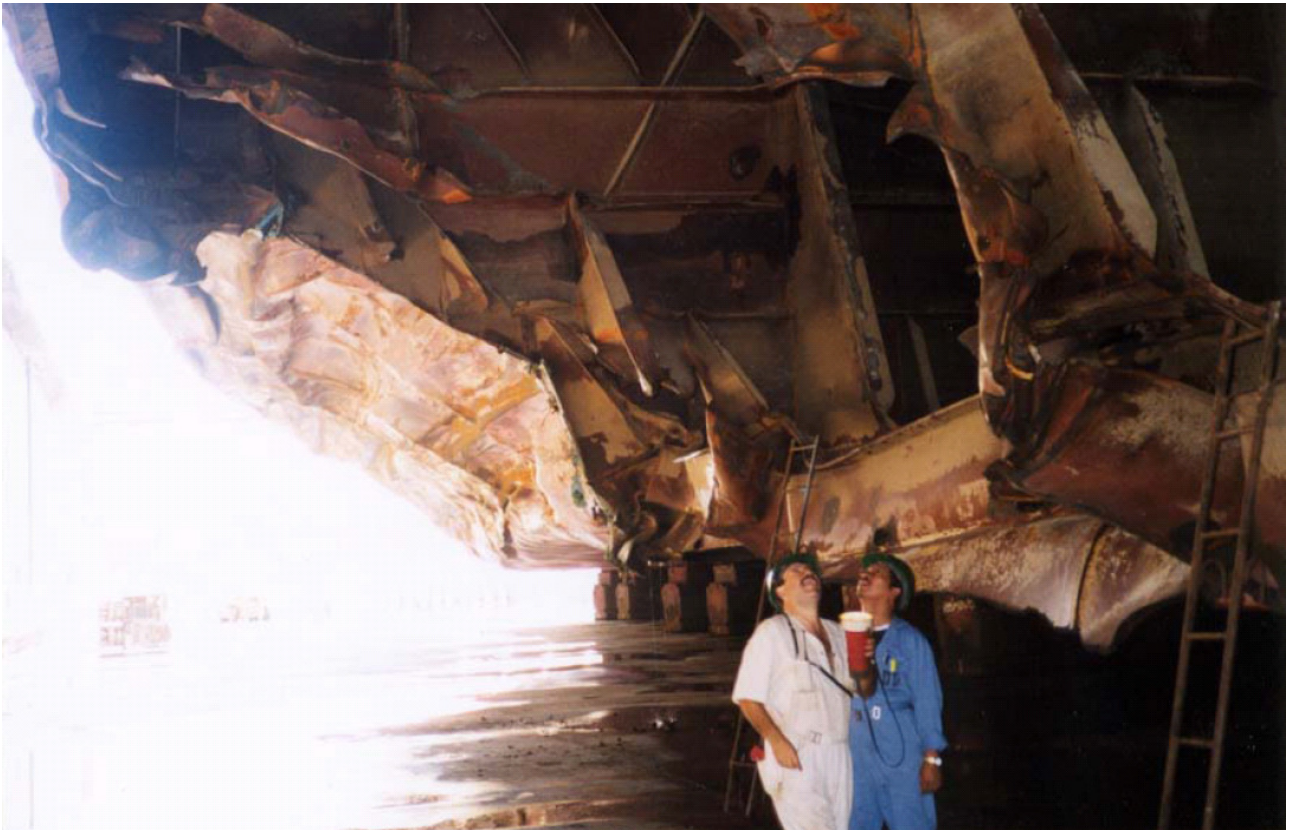
**Figure 5 A rip-up ship in a dry dock**

Relatively little dynamic energy can cause damages of considerable length.

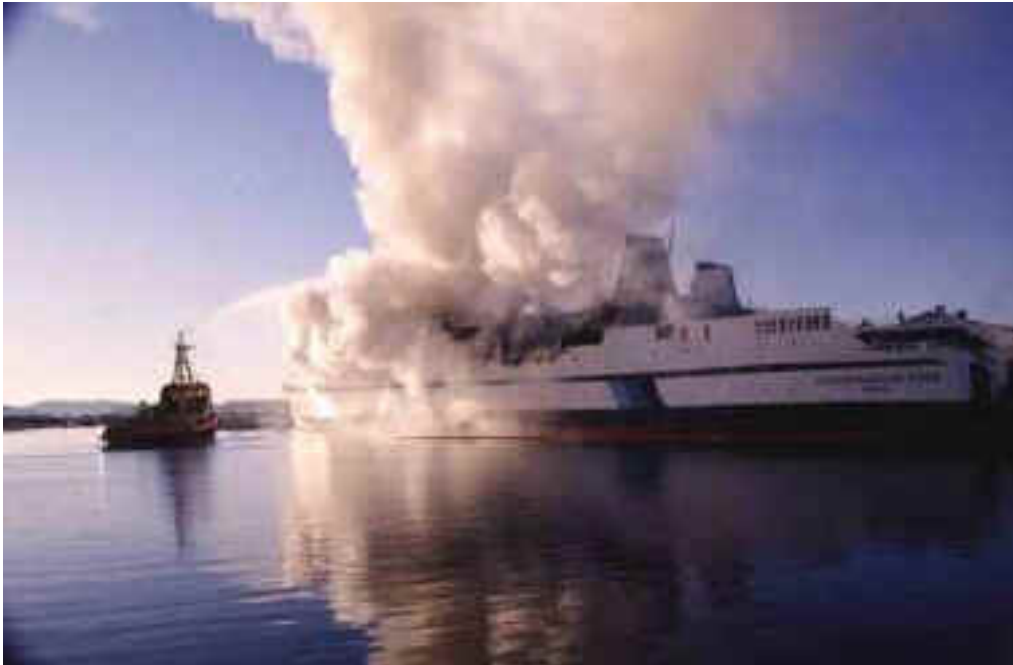
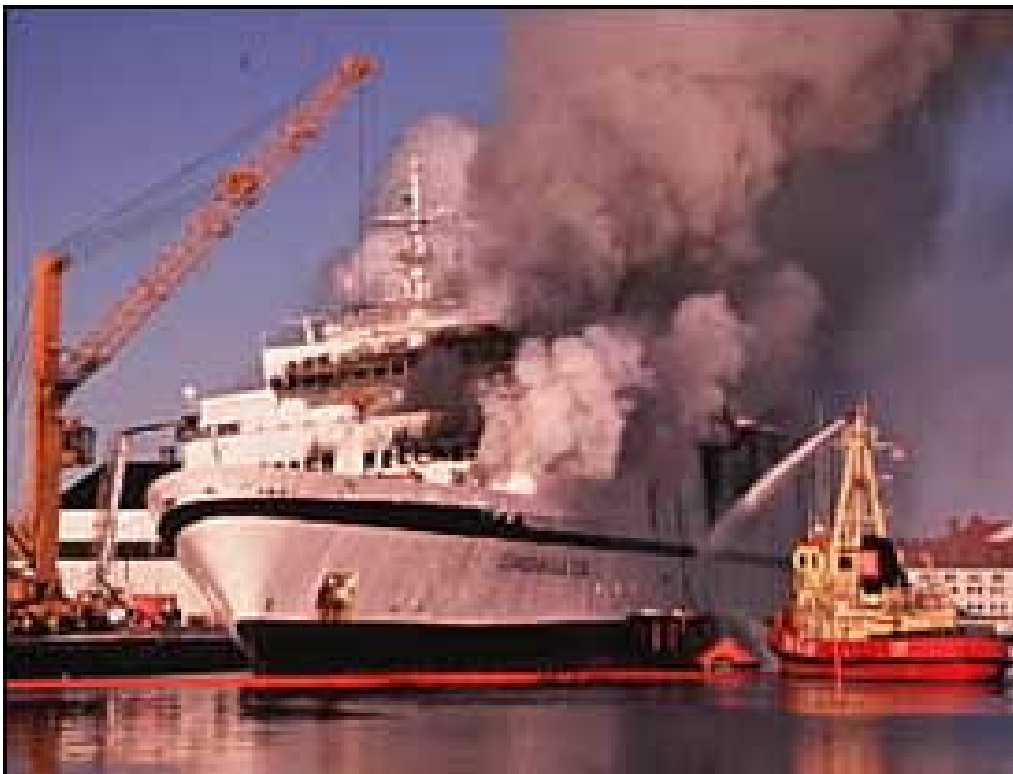
**Figure 6 Large scale fire on Scandinavian Star**

The pictures above demonstrates the problem with high located air intakes for pressurising areas around a fire zone.

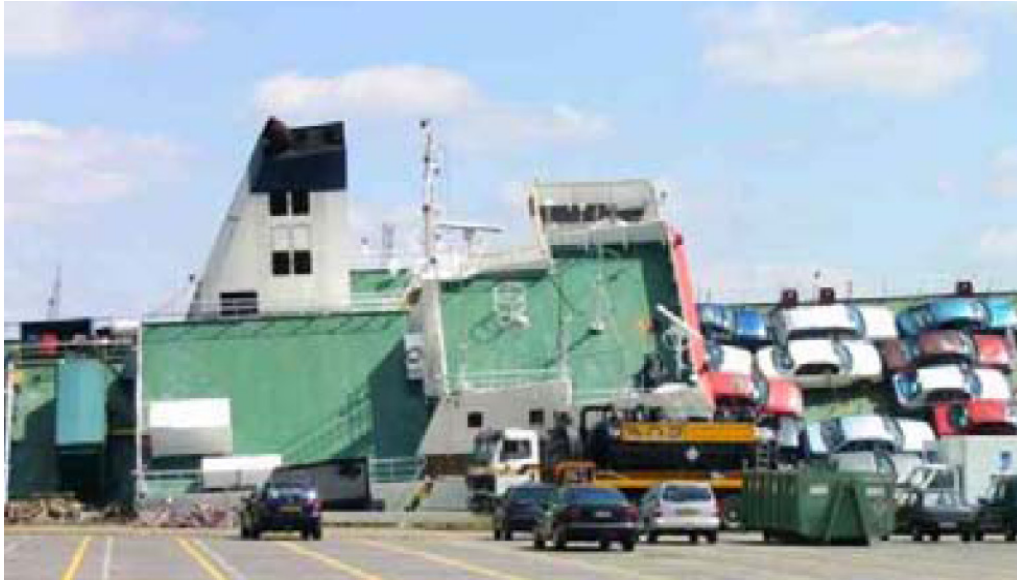
**Figure 7 Fire extinguished but the ship heeled over due to free water surface from fire fighting**

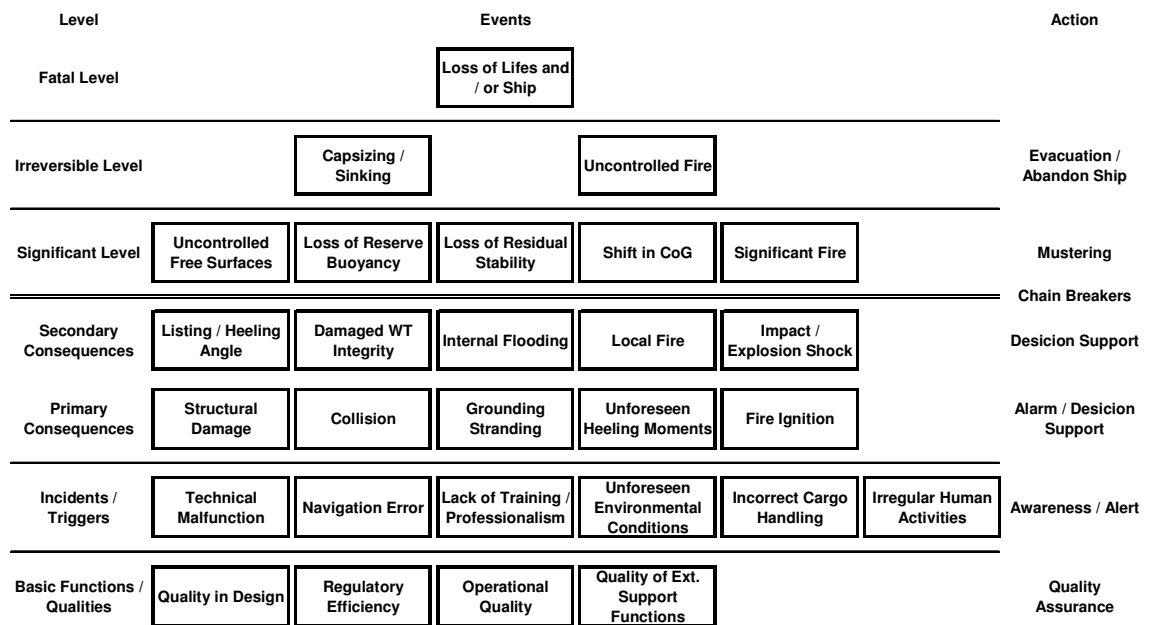
**Figure 1 WP4 and WP5 Chain of Events Flow Chart**

In order to, in a systematic way, search for and determine the significance of various design alternatives, WP4 and WP5 have together established a “Chain of Events Flow Chart”, Figure 1

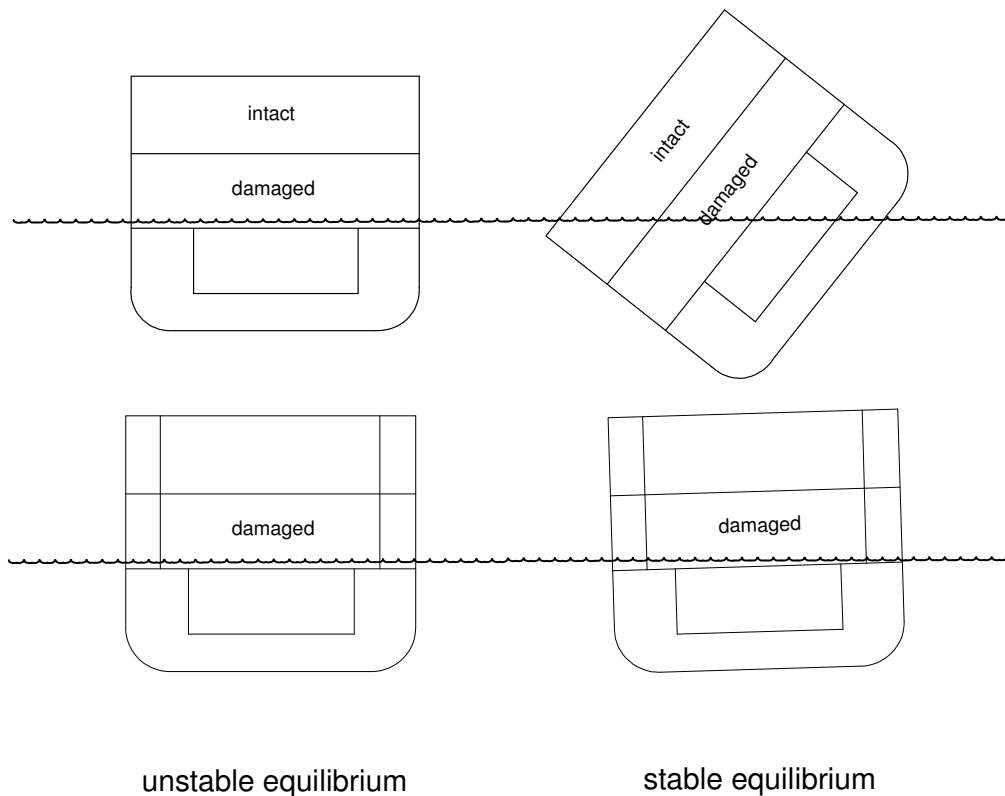
**Figure 2 Equilibrium with and without side casings for a large damage.**

The equilibrium will be unstable and if the superstructure above the main deck is not considered watertight the ship will turn upside down. If it is considered watertight, the ship will still have a substantial heel, basically depending on the height to the watertight deck above (but likely more than  $20^\circ$ ).

The list in the lower right side in Figure 2 is not due to the free surface effect. It arises from the side casing being damaged on one side only, i.e. a small asymmetry in the damage case.

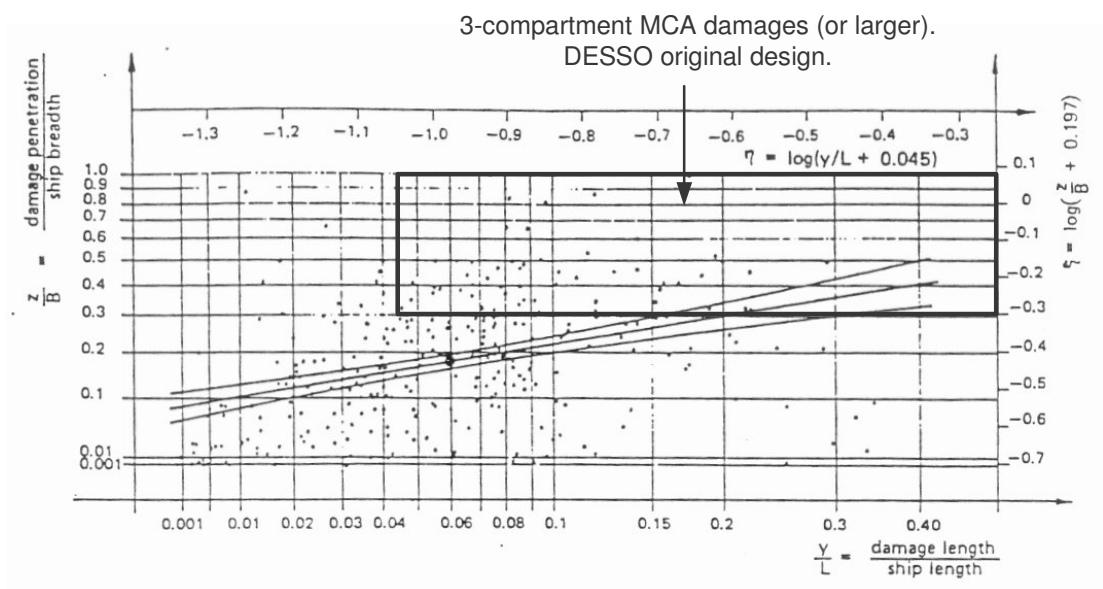
**Figure 6** Black dots in this graph represents actual damages on cargo and ro-ro ships,  $L > 100\text{m}$ . (Explanatory notes for probabilistic calculations. IMO SLF 35/20 ANNEX 3)

Figure 6 is a graph over damage statistics that shows damage length versus damage penetration for a large number of actual damages, represented by the dots in the graph, on cargo and ro-ro ships with lengths over 100 m. The damage extension inside the rectangle corresponds to the 3 compartment MCA damages on the template ship. Damage extension is of course dependent on the structural arrangement of the specific ship in but this graph can give some conception of the probability of a certain damage extension on the template ship.

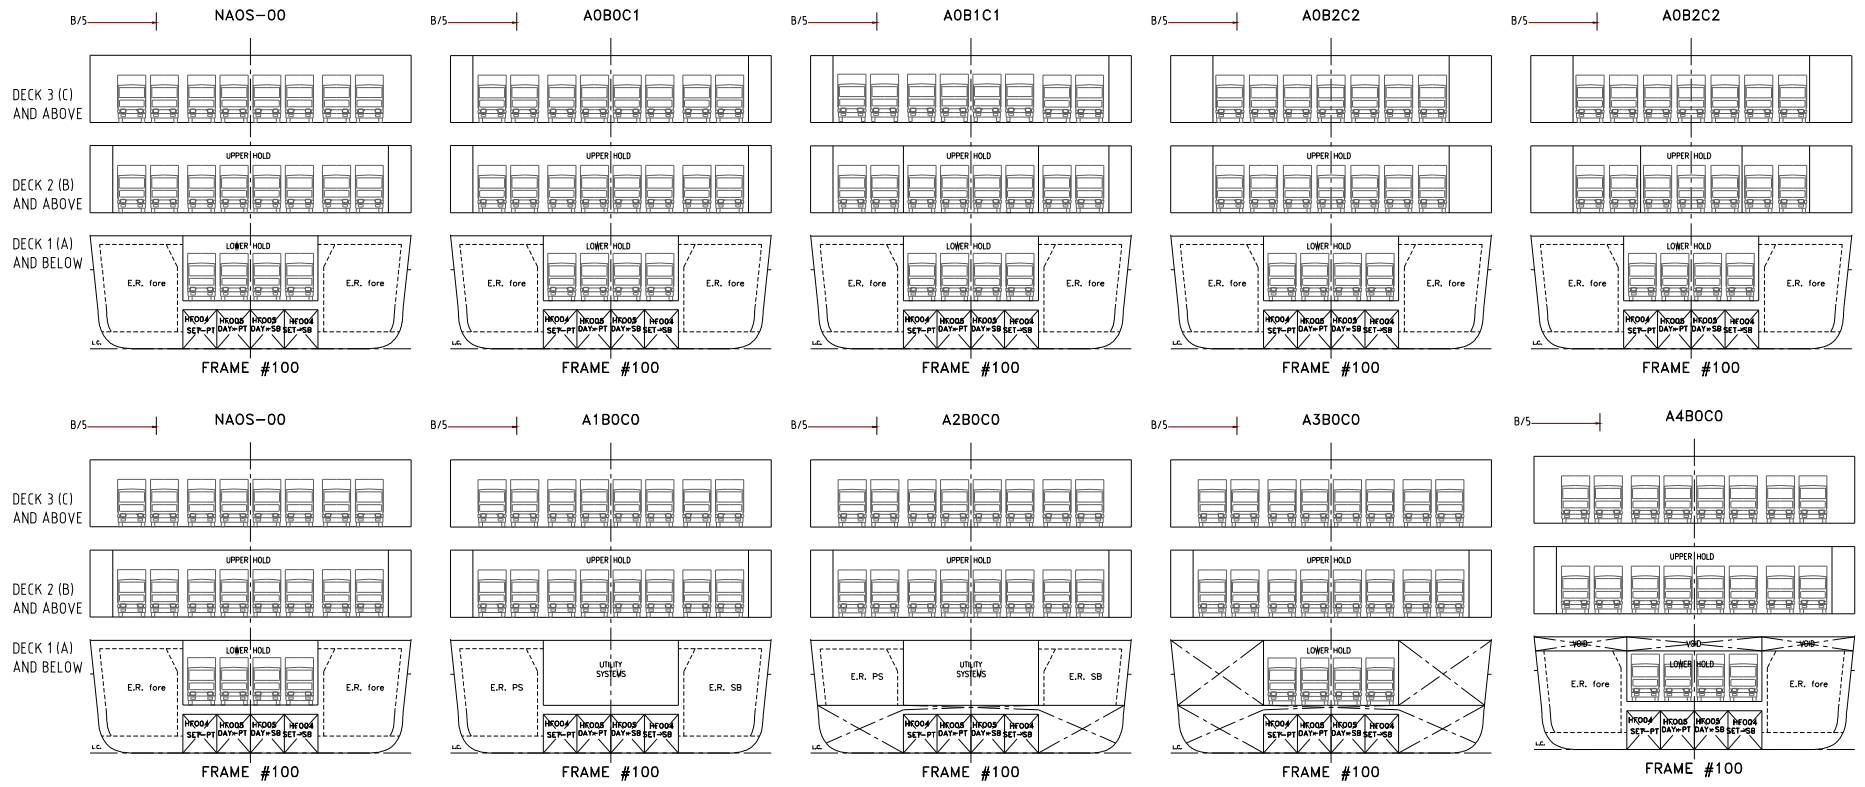
Figure 16 First Concept Generation - Alternative Watertight Integrity Arrangements

Based on the above, a number of alternative watertight integrity concept arrangements below freeboard deck have been worked out and analyzed, see Figure 16 First Concept Generation - Alternative Watertight Integrity Arrangements.

- A3B0C0* This arrangement comprises a more traditional machinery arrangement, having two separate main engine rooms, one SB and one PS, each of which accommodating a pair of main engines mounted in parallel to a common gear per shaft. In order to achieve this arrangement the breadth of the ramp down to Lower Deck has been reduced from four lanes to two lanes in parallel.

- A4B0C0* The arrangement is similar to the NAOS-00 Original Design configuration. However, the free height of the lower deck compartments have been reduced from 5.75 m to 4.50 m which corresponds to the free height as stipulated for trailer traffic on the European roads. The excess in deck height has been re-arranged to enclosed buoyant void spaces. Recesses in this “life-belt” must be done in the way of machinery venting and uptakes.

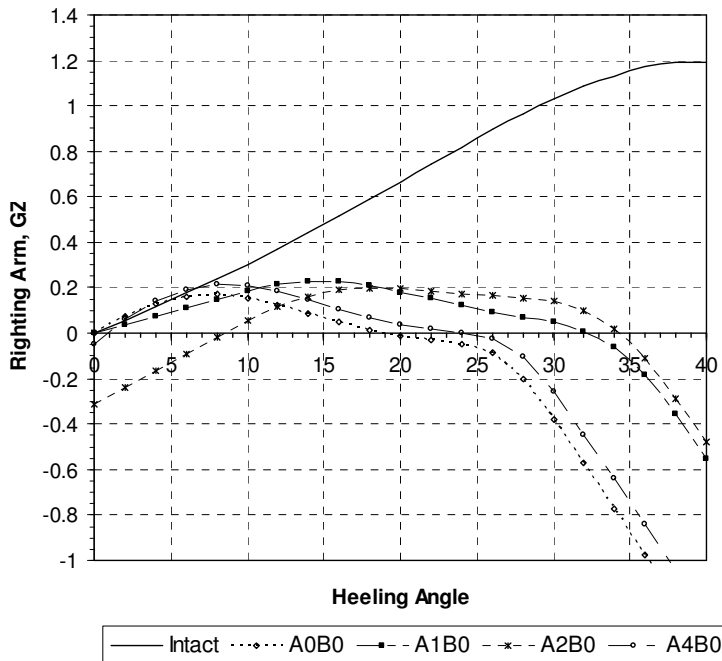
Figure 18 First Concept Generations – Assessment Curves

The results as presented in Figure 18 show that the arrangement A1B0 results in the most favourable righting arm curve providing some information on the stability-cost relation for the 412 Lane Meters.

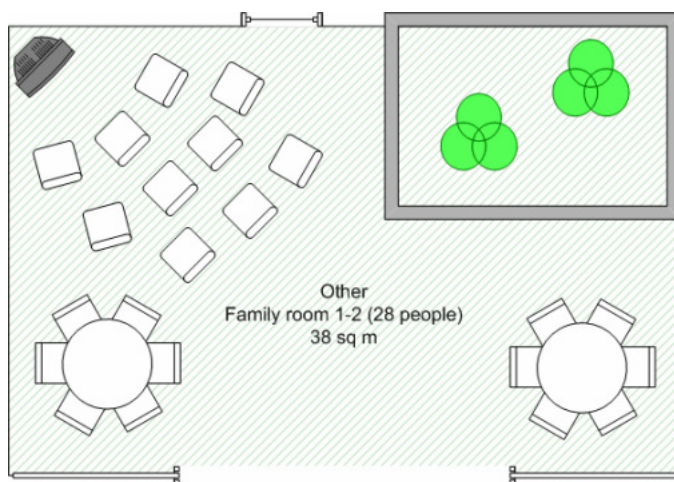
Figure 3 Example of different areas in the float free abandon capsule: café, cinema, family room and medical room.

In figure 3 examples of different passengers areas in the float free abandon capsule are presented.

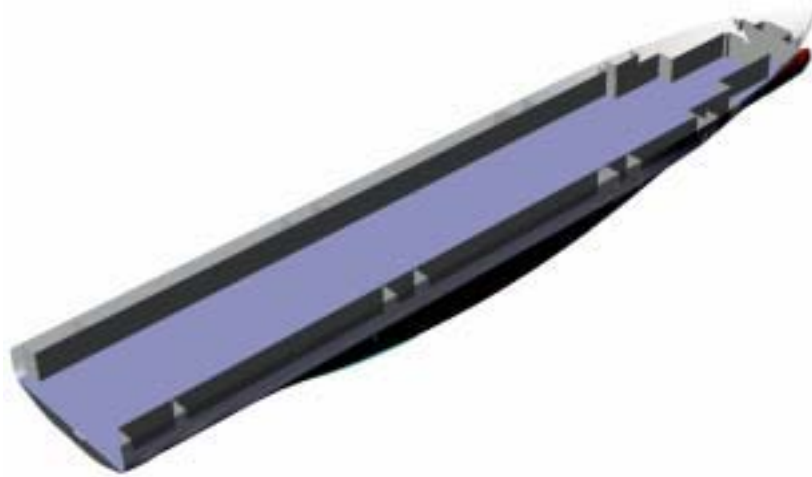
For the DESSO ROPAX ship, propulsive redundancy shall also remain after incurring damage that extends along three adjacent compartments or after a rip-up that penetrates the double bottom over 65% of the ship's length. To achieve this, the engines have been arranged in separate compartments where the aft engine rooms are also separated transversely. This is an exception to the aforementioned principle of cross flooding arrangements. For all three-compartment damage cases and for the rip-up damage considered for the DESSO ROPAX, at least one of the aft engine rooms will stay dry and provide propulsive and electric power. The asymmetric filling will be limited to the volume of one aft engine room, which is not large enough to cause a critical heel angle of the ship.

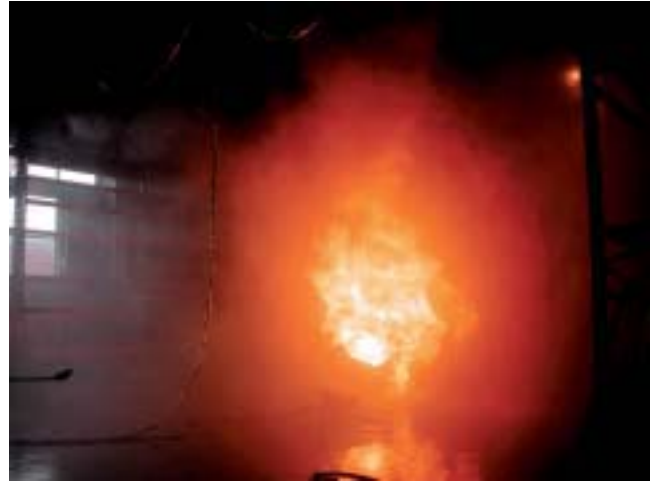
Figure 2: The entire DESSO ROPAX is protected by a high-pressure water mist system. A fire in a machinery space is shown above immediately after engagement of the system, and before the fire has been fully controlled.

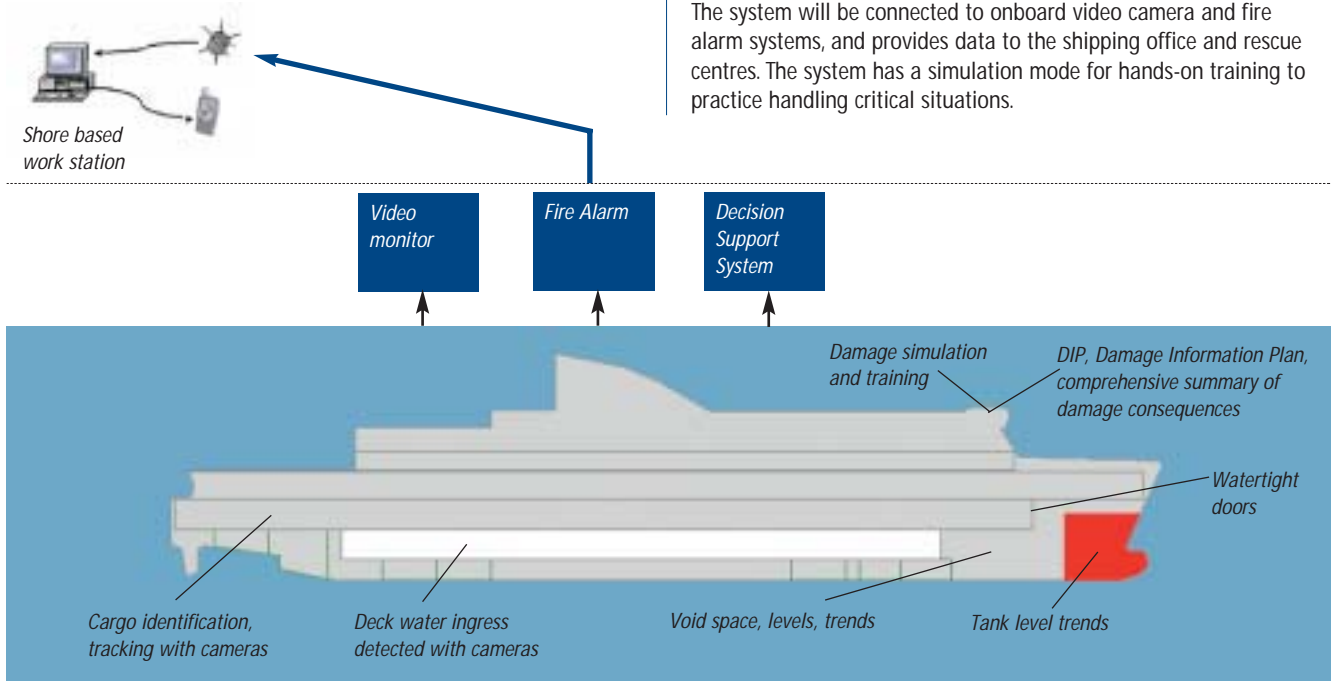
The system will be connected to onboard video camera and fire alarm systems, and provides data to the shipping office and rescue centres. The system has a simulation mode for hands-on training to practice handling critical situations.

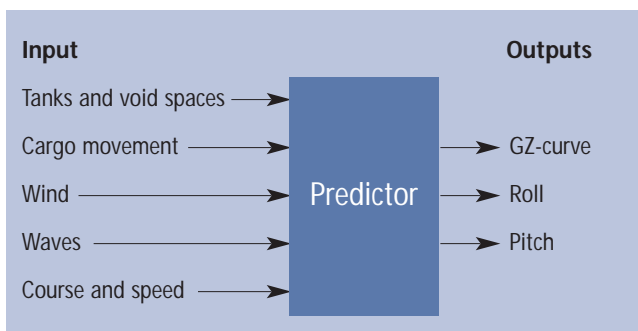
Prediction of the ship's present and future motions and state is based on an advanced mathematical model and measurements of the following:

- fluid levels in tanks and void spaces obtained from sensors or video image processing
- cargo shifting obtained from video image processing
- wind speed and direction
- wave height and direction (indirect computation from the ship motions)
- ship's course and speed
- meteorological wind and wave prognoses
